# Study of the Durability of a Mineral Bilayer Material: Case of Granito Coated Tiles

Bachir Kolade Adalakoun Ambelohoun, Koffi Judicael Agbelele, Yelome Judicael Fernando Kpomahou, Aristide Comlan Houngan. Study of the Durability of a Mineral Bilayer Material: Case of Granito Coated Tiles. *Advances in Materials*. Vol. 11, No. 4, 2022, pp. 77-84.

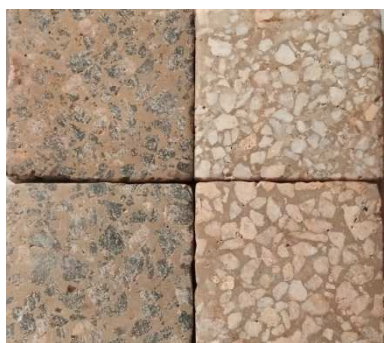
After this step, the granite coating is placed in such a way as to have a final bilayer sample of 4 cm thickness. Once the bilayer was obtained, we immersed it in water for 28 days. After 28 days, the surface of the sample removed from the water was sanded (figure 2).

Figure 2. Granite bilayers.

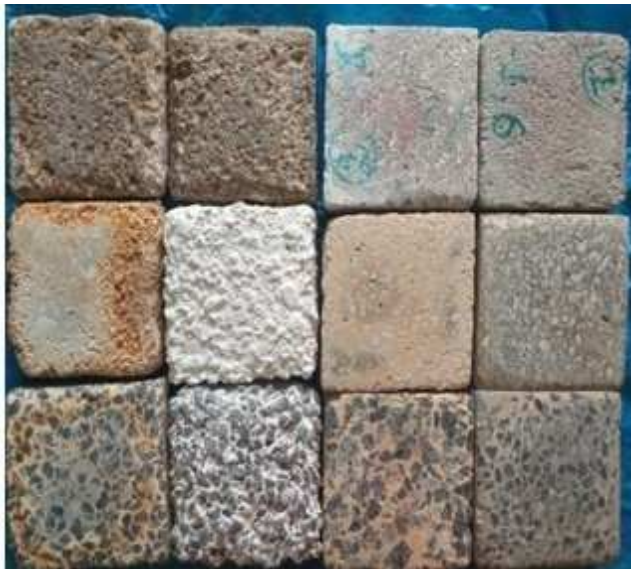
**Figure 9.** Surface condition of the samples after 35 days of immersion in  $HCl$ ,  $H_2SO_4$ ,  $CH_3COOH$  and  $NaOH$  and (from left to right).

immersion in the aggressive solutions, and Figure 9 shows the change in surface state of these samples subjected to attacks in the different aggressive media.

oxides, in particular the oxides of magnesium and calcium mainly present in the marble. Therefore, mass losses are recorded not only at the substrate level, but also and especially at the marble coating level. These losses are enormous in the sulfuric acid solution (figure 9, second column) where white precipitates of calcium sulfate (gypsum) and magnesium sulfate ( $MgSO_4$ ) are obtained. On the other hand, with the acetic acid solution, we note a strong ability of the marble coating to resist the chemical attack caused by this solution. The loss of mass in this case is due to a destruction of the cement paste coating the marble granites.

In contrast, chemical attack at the granite bilayer materials affected mainly the cementitious paste encasing the granite crushes and the substrate. In all three acid solutions, no loss is recorded at the granite coating, which protects a large part of the substrate from any chemical attack. Nevertheless, the chemical attacks taking place, caused a progressive destruction of the cementitious paste, thus weakening the bond between the granitos which end up progressively detaching from the coating, exposing the substrate (Figure 9, 3rd row and 1st column). This observation was more noticeable in the hydrochloric and sulfuric acid solutions than in the acetic acid solution, which seems to be non-aggressive to these materials.

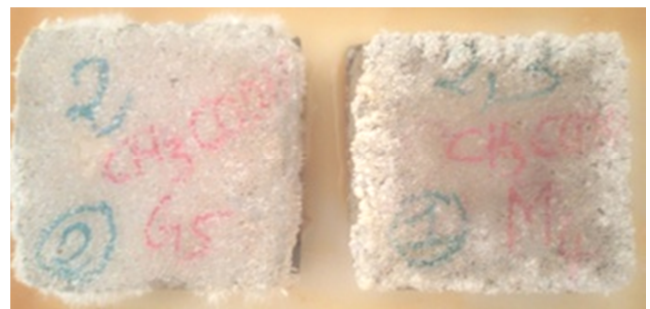
**Figure 10.** Surface appearance of specimens immersed in  $CH_3COOH$ .

In addition to these different observations, a thick whitish layer appears in the acetic acid solution (Figure 10). In addition, we observe an intense effervescence during five minutes following the introduction of the test tubes in the hydrochloric acid solution and the appearance of a yellow coloration.
